INTEGRATED APPLICATION OF ADVANCED SURVEYING TECHNIQUES AND BIM FOR INSPECTION AND ASSET MANAGEMENT OF REINFORCED CONCRETE BRIDGES

Miguel Azenha ⁽¹⁾, Gabriel Sousa ⁽¹⁾, José Matos ⁽¹⁾, José Sena-Cruz ⁽¹⁾, Vitor Brito ⁽²⁾

(1) ISISE, University of Minho, Guimarães, Portugal

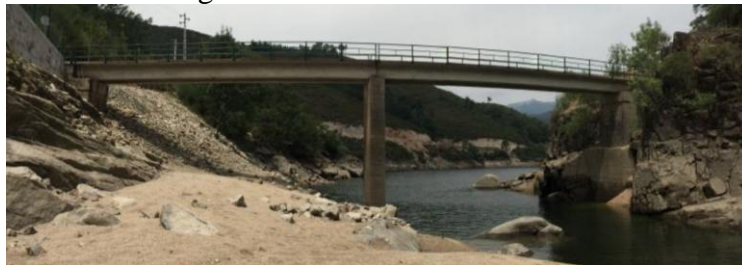
The Saltadouro Bridge is located in the North of Portugal, within the Natural Park of Gerês (Ruivães). It has been built in the 1950's, but the owner did not have any drawings or written records of the bridge design. The bridge, whose recent photo is shown in Figure 1, has two free spans of approximately 16.8m each, supported in a central column and two lateral abutments. The cross-section of the bridge is a double "T", with two longitudinal ribs supporting the top slab (all monolithically connected to each other). As seen in Figure 1, the water height is different in both spans of the bridge. For that reason, and taking into account the similar apparently similar state of both spans, the detailed inspection has been focused on the leftmost span according to Figure 1 (South side), which was made accessible by a specifically assembled scaffolding.

Figure 1: Overall view of Saltadouro Bridge (left side: North abutment; right side: South abutment).

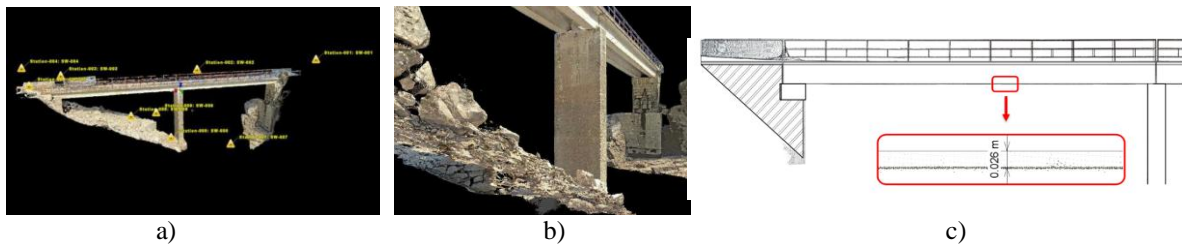
distance meter, measuring tape) and laser scanning techniques were applied for mutual validation. The laser scanning was carried out with a Leica ScanStation P40 with the following main features: survey of 1.000.000 points per second, range of 240m, 1.2mm precision (± 10 ppm) and integrated digital camera. The equipment was placed at 8 different measuring stations in order to cover the entire structure, as identified in Figure 2a. The resulting global point cloud has more than 170 million points. One view of such point cloud is shown in Figure 2b. From a structural point of view, it was interesting to note that the accuracy of the obtained point cloud, allowed to compare the actual shape of the bottom surface of the beams, to the hypothetical straight line that connects the supports, and therefore infer the deformation. As shown in Figure 2c, a deformation of 2.6cm could be assessed in regard to the fictitious straight line, and the noise level of the point cloud is compatible with the 1.2mm precision mentioned above. This level of accuracy brings laser scanning to a great degree of usefulness in accompanying the deformational behaviour of structures, indeed. It is also remarked that, as expected, all tape measurements have validated the measurements that could be made directly on the point cloud.

Figure 2: Laser scanning: a) location of stations; b) view of the point cloud; c) deformed shape in comparison to reference line

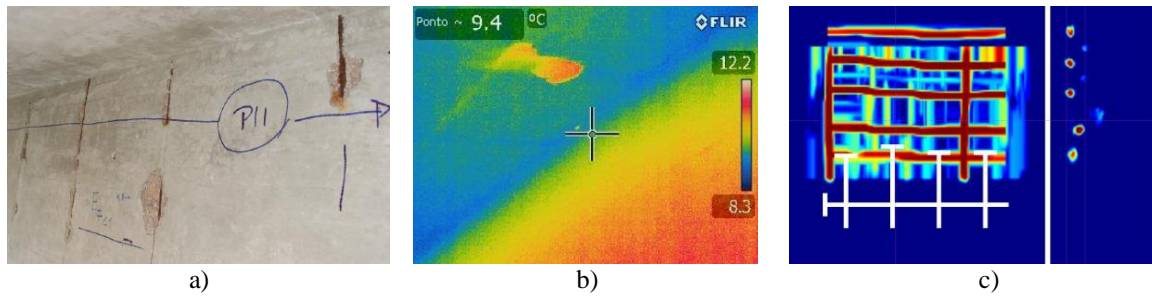
The inspection has also involved several inspection techniques that are briefly addressed here. Visual inspection (together with photographic record) allowed the traditional identification of biological colonization, corrosion, surface delamination and suchlike (e.g. corrosion and delamination in Figure 3a). Infrared thermography was also applied with a FLIR E50bx camera, that allowed recording several barely perceptible delamination processes to the naked eye (Figure 3b). In order to assess the rebar diameter, position and type, several minor destructive inspection activities were made, by opening cavities up to the reinforcement (here termed as inspection windows), and even gathering a few rebar samples for lab testing. Two steel rebar detectors were used together in order to get a global picture of all reinforcement distribution within the ribs and the deck: a Hilti PS200 detector and a Hilti PS1000 GPR based scanner. An example of the GPR imaging obtained can be seen in Figure 3c. Seven concrete cores (with ~ 10 cm diameter) were obtained from the bridge and tested in laboratory (Figure 4a). Schmidt hammer assessment of compressive strength was also assessed at 24 distinct locations. Cracks were marked with a felt pen and photographed, whereas a set of representative crack widths were measured with a handheld USB Microscope VEHO VMS-004D, that could accurately pinpoint widths to the hundredth of millimetre (Figure 4b).

Figure 3: Inspection techniques: a) photography record of corrosion and delamination; b) infrared thermography image; c) GPR image obtained with a steel rebar detector

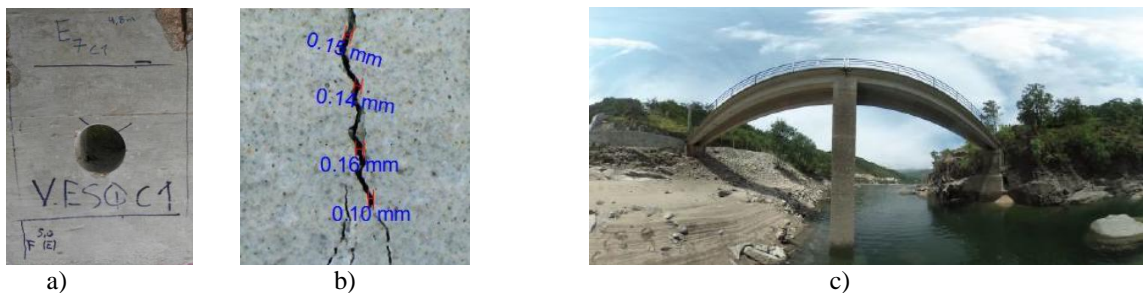
The photographic record of the bridge was also taken through 360° photography at 7 locations with a Ricoh Theta camera. An example of a flattened spherical panorama can be seen in Figure 4c. These spherical photos can be of great utility due to the quickness in which they are obtained and the embedded richness of context.

Figure 4: Inspection techniques: a) core extraction; b) crack width; c) 360° photography

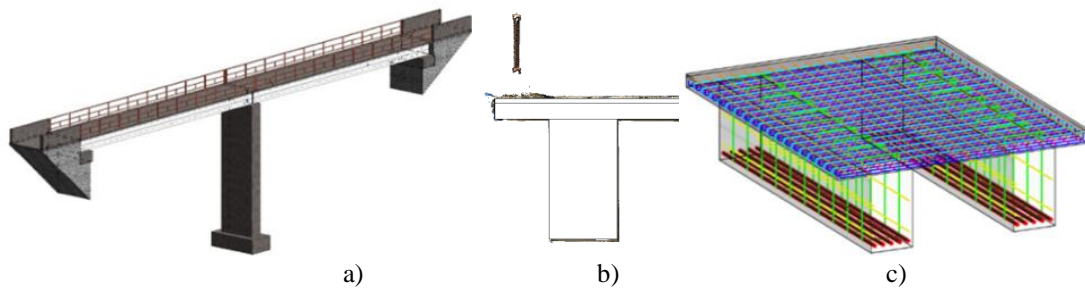
The selected application for modelling was Autodesk REVIT, following a structural template that encompasses native object classes for such purpose. The point cloud was embedded as a reference in the BIM model and used to support the geometry definition throughout the entire process. In regard to the level of information/detail/development to be included in the model, it was decided to follow similar prescriptions to those provided by BIMFORUM/AIA for LOD400 [5], which means that reinforcement was explicitly modelled. Warping/deformations of the structure's geometry were not explicitly modelled, with the idealized undeformed geometry being considered sufficient for the intended use of the model. The final BIM model is shown in Figure 5a, with a specific comparison of the idealised geometry of the model with the point cloud being shown in half cross-section in Figure 5b. A view of the modelled reinforcement is shown in Figure 5c.

Figure 5: BIM Modelling: a) global overview of the model; b) comparison of BIM model and laser scanning at cross-sectional level; c) part of modelled reinforcement

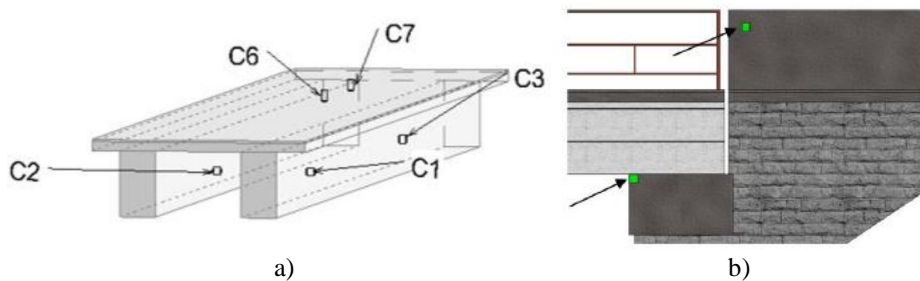
The modelling of inspection information can be made either explicitly, as shown for the cores exemplified in Figure 6a (which incorporate core objects that embed the relevant information of compressive strength, laboratory test sheets, carbonation depth, etc.) or in an implicit manner through 'patch' objects, such as the green patches shown in Figure 6b, which stand for the observed biological colonization. The mentioned patches are BIM objects themselves with relevant fields that characterize the information considered relevant (e.g. type of colonization, extent, link to photo, etc.) in such a way that it remains interoperable and exportable in a specific IFC 'property set'. The authors consider that, for the sake of BIM-FM purposes, damages and inspection information (including cores, cracks, inspection windows, etc.) are well represented through the 'patch' strategy, that allows embedding all the necessary information in an easy to systematize/query manner, and indexed to the relevant date of inspection. Furthermore, scripts have been developed within Autodesk REVIT (Dynamo-Python) that allow that inspection data can be inputted or analysed directly in Microsoft

Figure 6: BIM Modelling: a) explicit modelling approach for cores; b) patch modelling approach for biological colonization

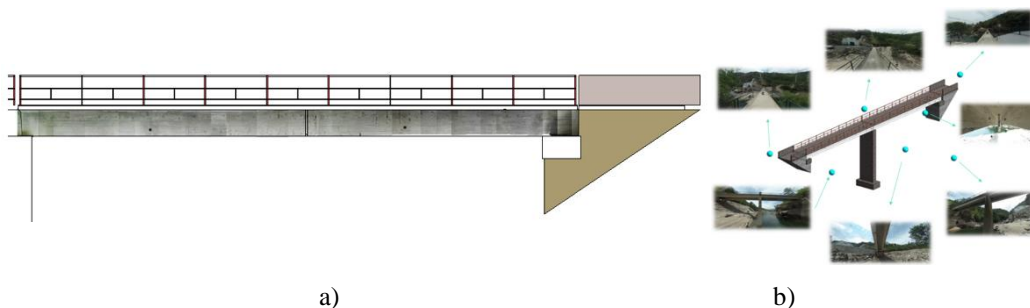
Another important aspect to preserve is the visualization of inspection/damage data. Not only is the point cloud of each inspection preserved in the BIM model, but also photogrammetry-composed images of beam surfaces can be embedded into the model's surfaces (see Figure 7a), and spherical panoramas can be embedded into specific 'sphere' objects located at the exact spot where each 360 photo was taken in the inspections, as shown in Figure 7b. This has important benefits in the perception of evolution of damages by an experienced user that wants to navigate the model and observe the evolution of surface damages/aspect. Finally, the work reported herein has also tackled with success aspects related to semi-automatic inspection report generation (drawings) and exporting the model to BIM viewers (including through the use of the open IFC format) that allow the observation of the model and all its data to be made by stakeholders that might not hold licensing for BIM Software.

Figure 7: BIM Modelling: a) photogrammetry stitching on the surfaces of objects; b) sphere objects to host spherical panoramas
